# Capitalizing on a failure

CASE HISTORY

## Niagara Mohawk up-rate at a glance

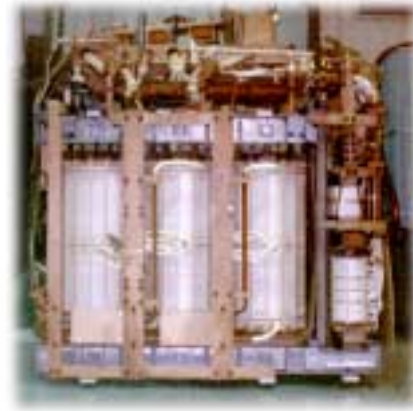
In a typical hybrid insulated core-form transformer repair, the hot areas requiring NOMEX® brand insulation are limited to conductor wrap, radial spacers and axial sticks, as is shown in the picture of the NIMO unit above. This usage results in a unit with a 95°C average winding rise. In another option, Southwest also has rebuilt transformers using NOMEX® as a conductor wrap only. This results in a 75°C rise unit with a smaller capacity increase (see "Another repair option" on the next page).

In cases where a significant up-rate is required, Southwest offers a hybrid insulation system. In this option, the cooler areas in the transformer are insulated with traditional cellulose material, while NOMEX® brand insulation is applied to the hotter areas.
